**uAvionix skyBeacon/tailBeacon  
GPS Performance Troubleshooting**

**UAV-1004106-001  
Revision B**

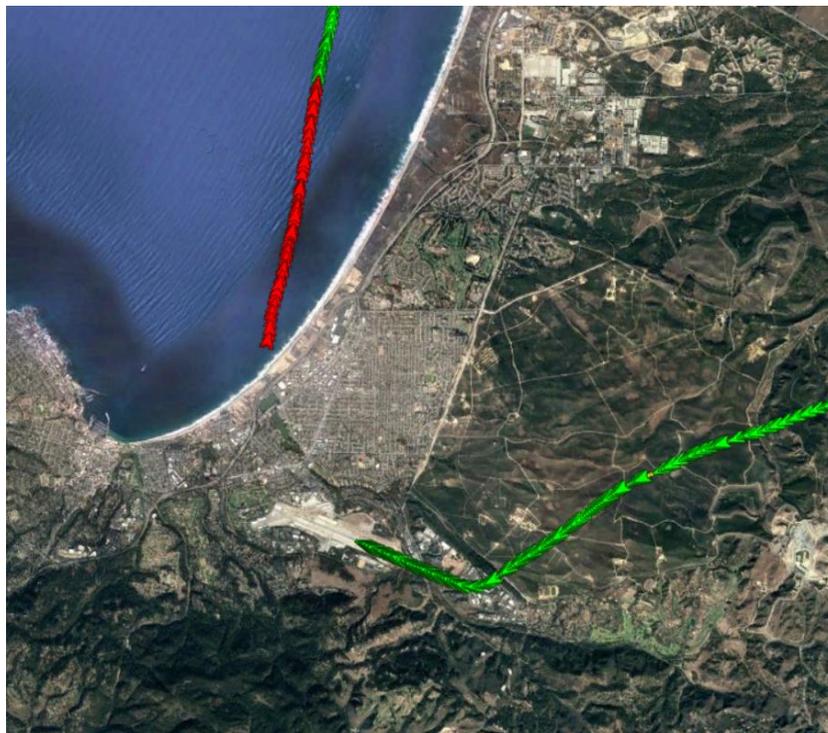
Review where the failures occurred. If the failures occur during takeoff roll and climb out with no further failures occurring in the flight track, the cause is likely insufficient runup time for the skyBeacon/tailBeacon. A high integrity fix takes time to acquire. The owner/operator might consider altering the aircraft checklist to help reduce this issue and improve compliance.

The aircraft above took off prior to having a high integrity fix. Turning on the navigation lights and skyBeacon/tailBeacon early in the aircraft runup helps prevent this type of failure.

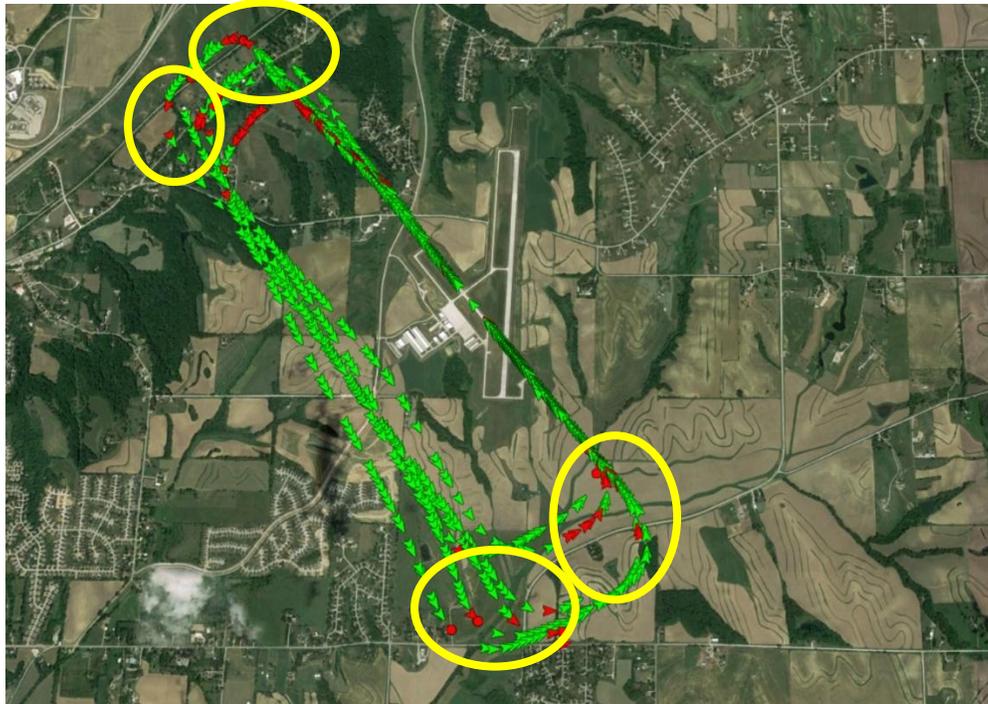
In the image above the GPS reporting fails integrity or loses position each time the COM radio is keyed. The positions of failure match normal call up locations during pattern work. This aircraft appears to be experiencing RF interference. See Section 5.2 for guidance on RF Interference troubleshooting.

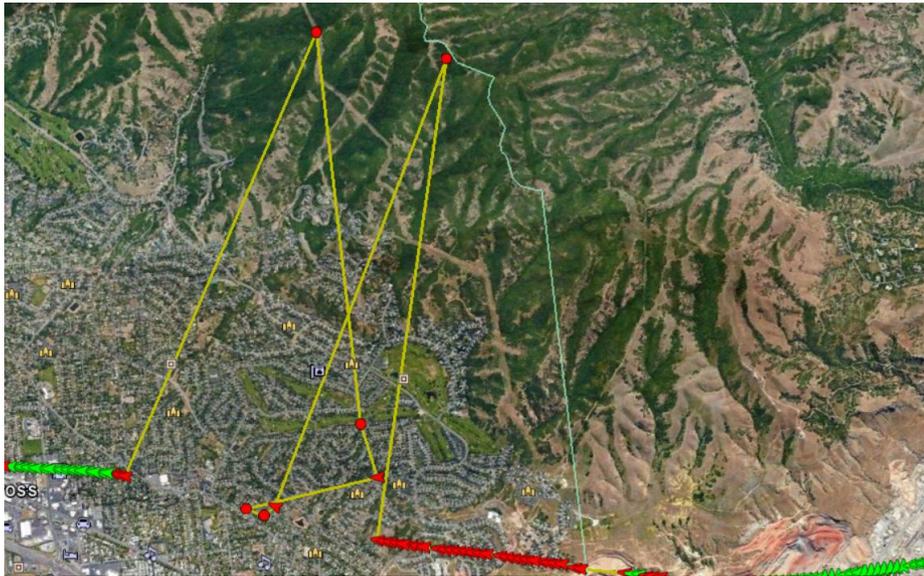
As shown above the flight track jumps unexpectedly and well outside the capability of the aircraft.

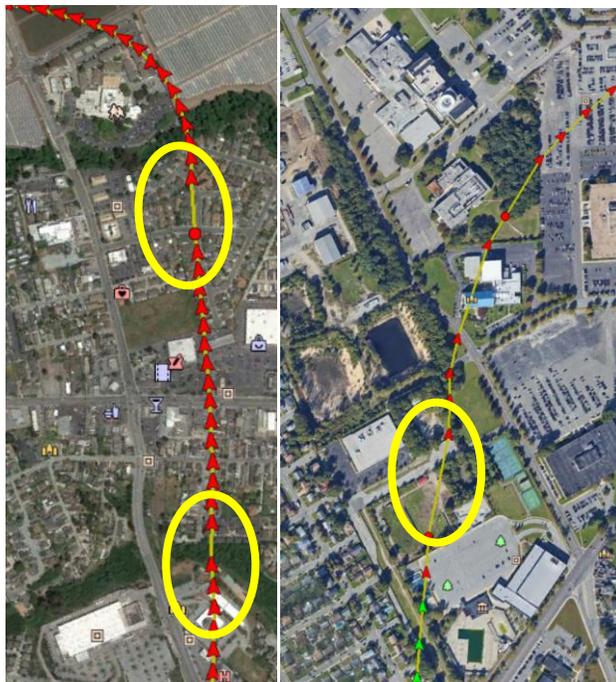
A loss of GPS position will appear as gaps in the flight track. Typically, the gap is larger than a single missing message. Due to the nature of radio performance, focus on gaps greater than 5 seconds.

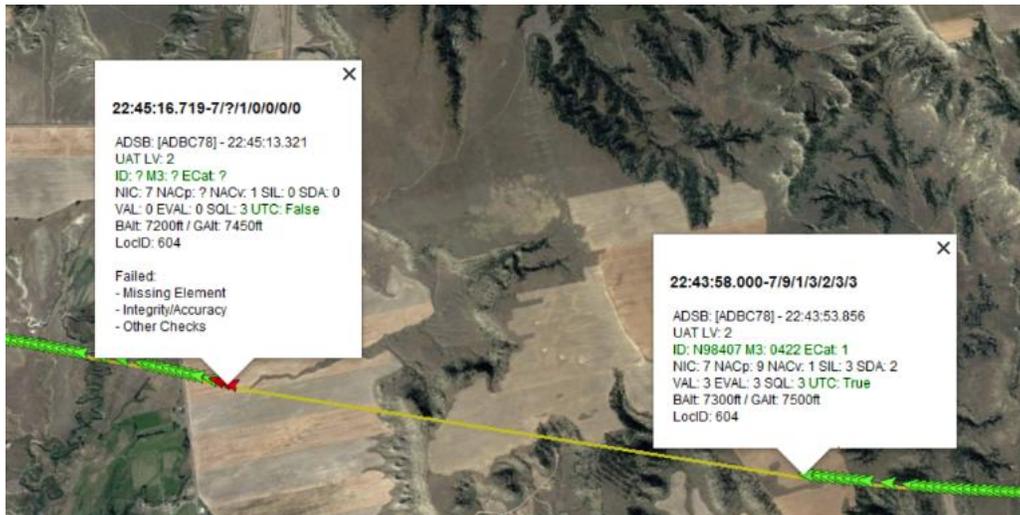
In the example above the aircraft callsign (ID), Mode A (M3), and emitter category (ECAT) are missing/invalid after the unit resumes transmission. The UTC sync is also *False*. The unit above is experiencing resets due to a power related event. The reset appears in the data as a loss of GPS reception but the supporting date indicates the skyBeacon/tailBeacon hardware momentarily lost power.

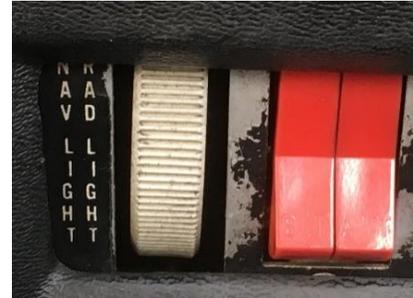
Some aircraft use a rheostat to control the Nav lights for dimming purposes. We recommend replacing these style switches. Many of these rheostats or potentiometers are several decades old and it has been observed that a little vibration or a slight change in position will break the connection. The skyBeacon/tailBeacon will not operate correctly without proper voltage and grounding. A switch that is malfunctioning and or not delivering a consistent connection will result in failure to meet the performance of 91.225 and 91.227.

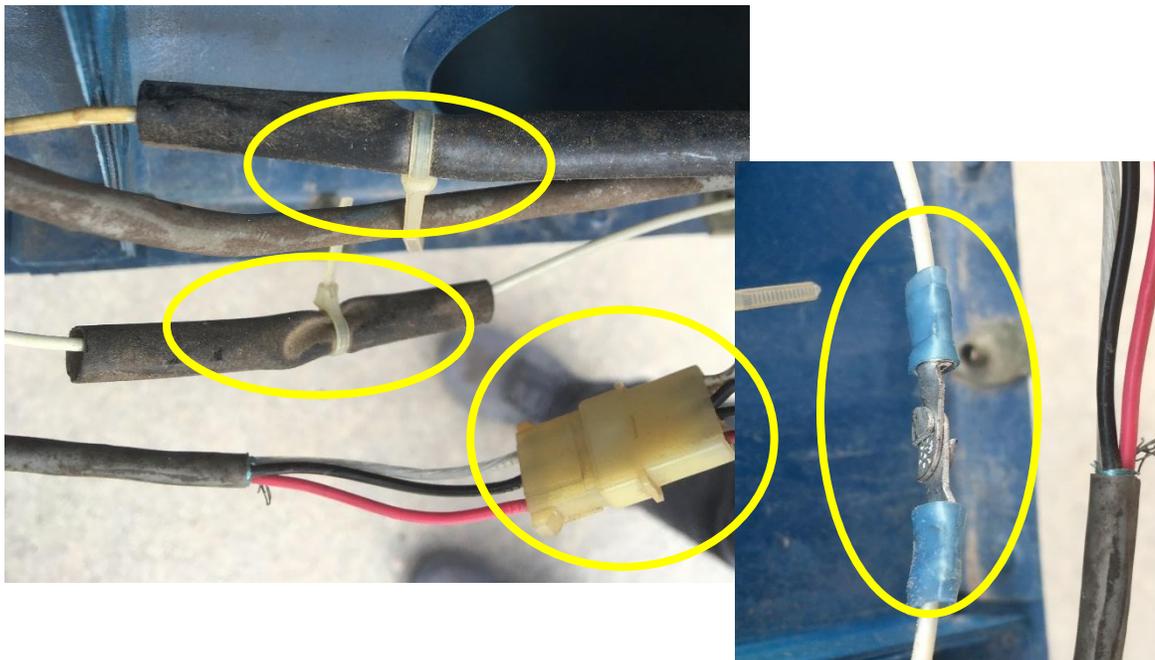
While popular, the knife or blade style termination does not meet the recommendations of AC 43.13-1B. The connectors are not sealed and the nature of the connection can result in a high-resistance. The same is true for the common unsealed Molex style plugs. AC 43.13-1B recommends an environmental (sealed) splice.

Below are examples of termination that do not meet the requirements of AC 43.13-1B.

skyBeacon/tailBeacon include high quality Molex environmental splices. When crimped with an insulated crimper and heated they will provide a high-quality low-resistance connection sealed from the environment. If a removable connector is desired please use a positive locking environmentally sealed connector.

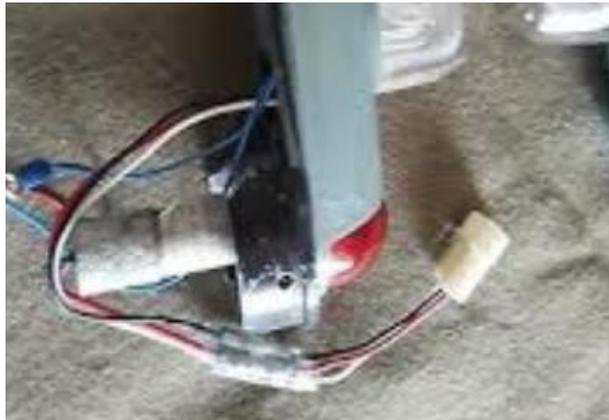
The photo above shows a series of wiring with three butt splices and a Molex plug on the same short section of power wiring. Presumably the mating side under the wingtip also has the same chain of wiring, compounding the chances of a failed connection and increasing the resistance. If both sides of the installation have three additional butt splices there are a total of twelve additional and unnecessary failure points.

Avoid using multiple terminations to extend a power or ground wire. If existing connectors are discovered we recommend removing all of the unnecessary terminations/extensions. The greater the number of splices the greater the chance termination failure will occur.

A single termination is recommended. In extreme cases a new wire should be pulled to the skyBeacon/tailBeacon. If a new wire is required, we recommend installing a dedicated ground wire at the same time. 22 AWG or larger is advised.

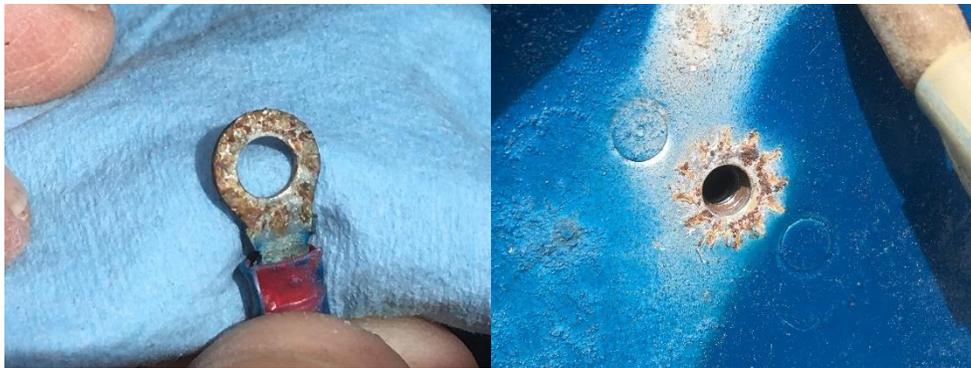
The photos of the above ring terminal and ground location show significant corrosion. The high resistance connection resulted in failure of the attached avionics. Removing the existing corrosion and existing paint/coatings along with replacement of the ring terminal resolved the performance issues.
