Qualified Installer Guide to Understanding PAPER Failures

© 2019 uAvionix Corporation. All rights reserved.

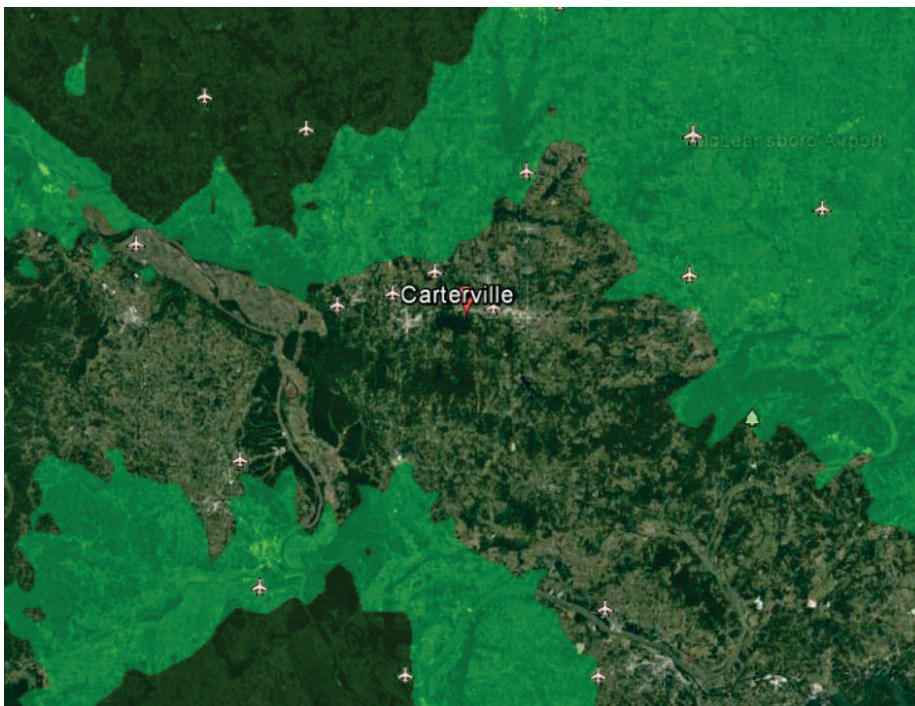
Now pull up Carterville, IL on Google Earth and turn on the ADS-B and Radar coverage at 500' AGL.

At 500AGL the radar (dark green) and ADS-B (light green) coverage are both non-existent. Depending on the field the aircraft departed from, and the direction of flight, a large gap and random failures are very likely. The data from the PAPR and the coverage map all support the fact that this flight likely failed due to coverage issues and not configuration or defective equipment. Detailed data can be requested to verify

that coverage was the cause. You or the customer can also contact the ADS-B rebate help desk ADSBRbateHelp@faa.gov with the date and callsign to request a manual review.

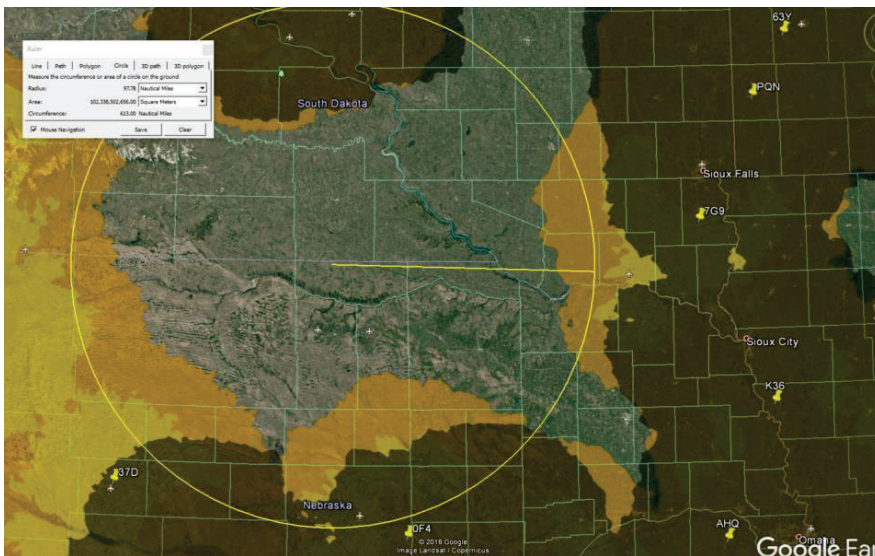
The screenshot below shows a portion of South Dakota. The thumb tack icons are ADS-B ground stations. The orange represents ADS-B coverage at 1500'AGL. A flight flown inside a majority of the yellow circle will not be able to generate a report. The nearest ground station from the two airports shown in the center of the image is over 100 miles away. The failure likely has nothing to do with equipment.
