**uAvionix skyBeacon/tailBeacon  
GPS Performance Troubleshooting**

**UAV-1004106-001  
Revision B**

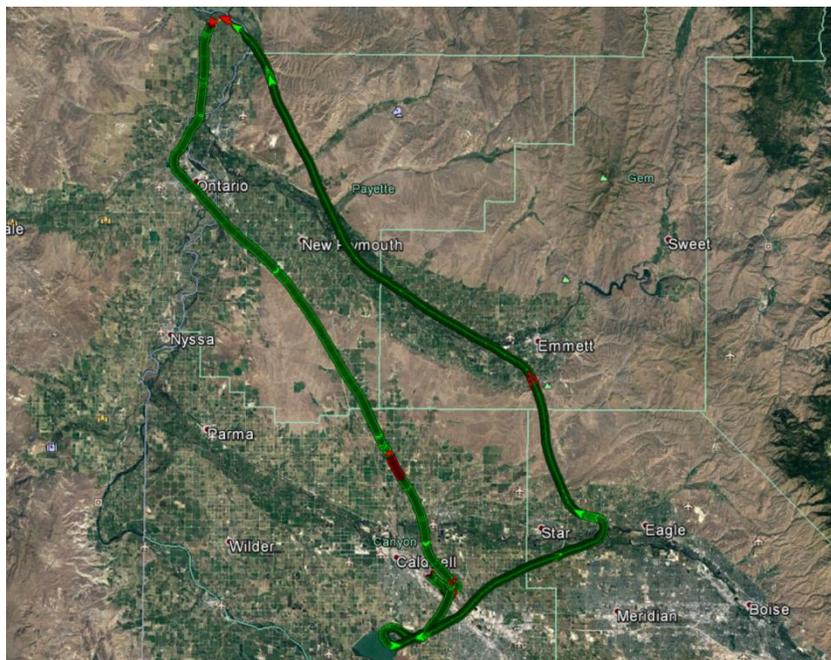
- Lower than acceptable integrity
- Loss of position or
- Misreporting of position

Characterizing the failure can provide insight into the actions required to resolve the performance issue.

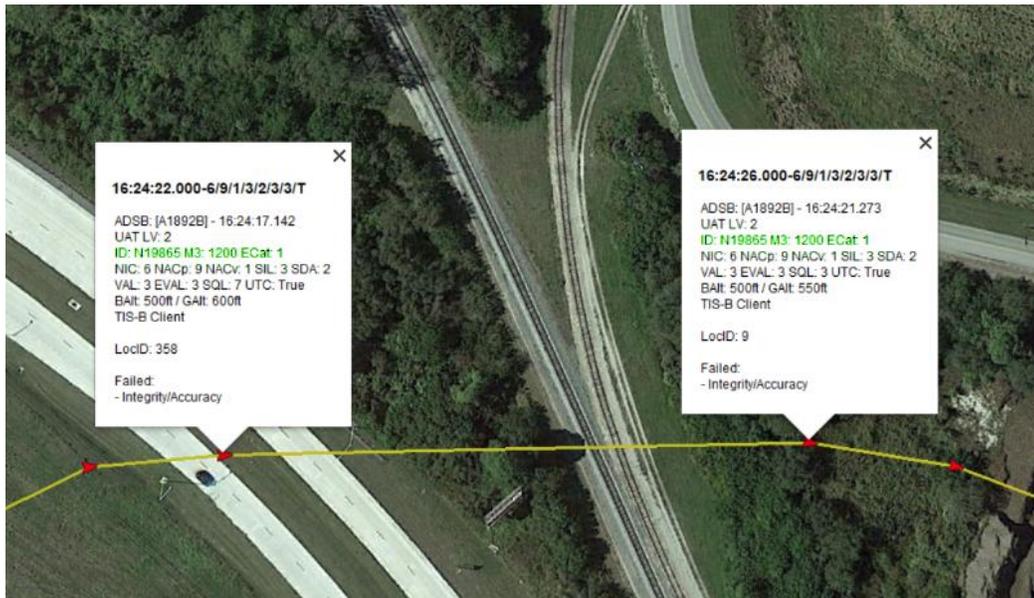
A loss of position without reset can be identified by reviewing the messages on either side of the gap. Each message on either side of the gap will contain a valid call sign and squawk. The UTC value will also remain unchanged, i.e. *True*.

The data in both transmits above contains valid information on either side of the gap. No fields are missing or invalid which indicates the skyBeacon/tailBeacon hardware did not reset or lose power.

In cases where the device has reset due to power loss the messages immediately after the gap will show missing or invalid data.

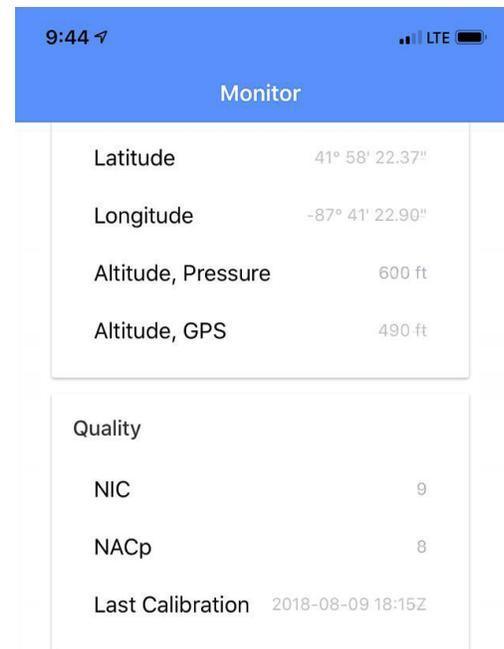
Monitor	
Latitude	41° 58' 22.37"
Longitude	-87° 41' 22.90"
Altitude, Pressure	600 ft
Altitude, GPS	490 ft
Quality	
NIC	9
NACp	8
Last Calibration	2018-08-09 18:15Z

If you are testing a radio transmitter other than a COM radio, verify the GPS does not lose fix and that the integrity metrics (NIC/NACp) do not change while transmitting on each available channel/frequency for 35-40 seconds.
