tailBeacon

TSO Service Bulletin

Software Upgrade to ADS-B 1.5.1

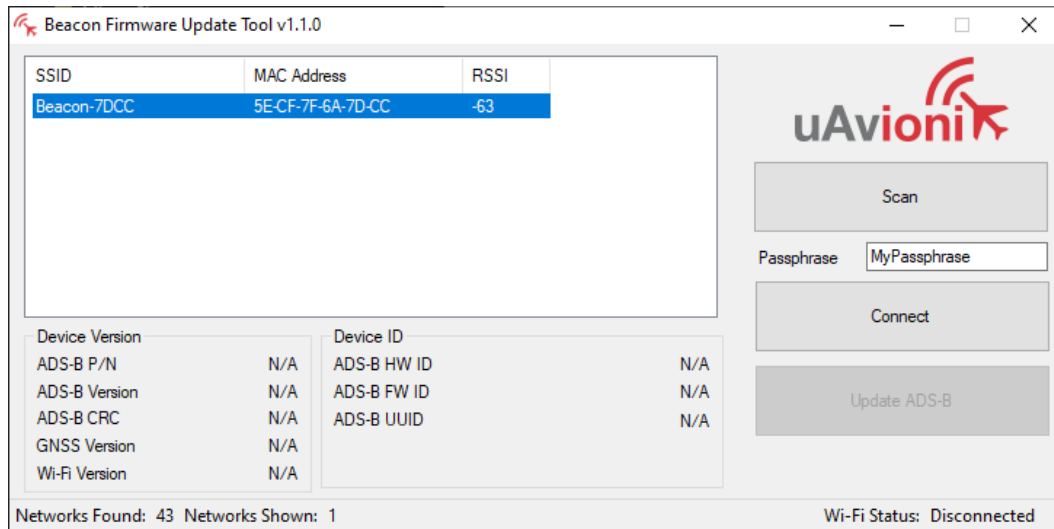
- Press “Scan” in the tool. A list of uAvionix Beacon products will populate the list in the upper left. Select the appropriate tailBeacon based on the known SSID of the device, as noted on the card included with the box or your maintenance records.
