tailBeacon

TSO Service Bulletin

Software Upgrade to ADS-B 1.5.1

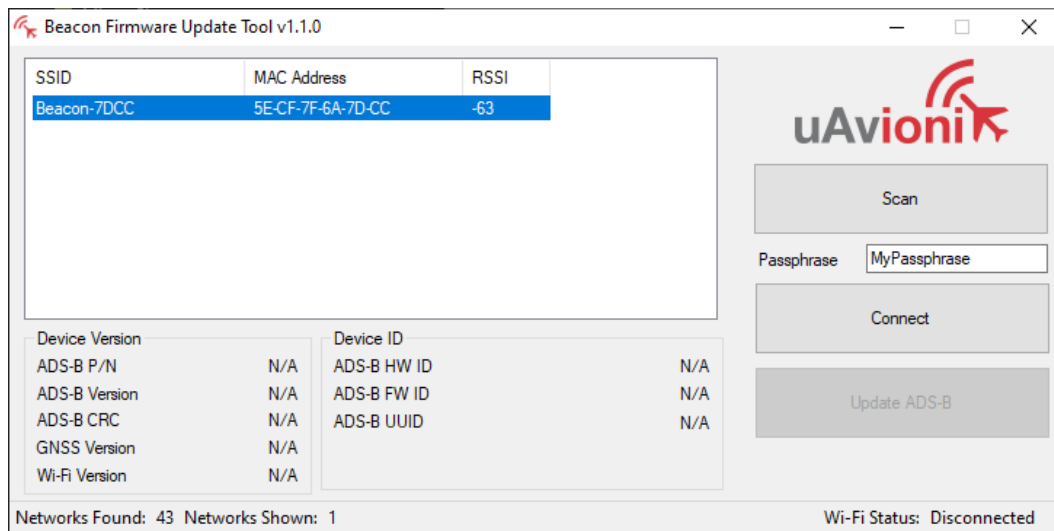
- Press “Scan” in the tool. A list of uAvionix Beacon products will populate the list in the upper left. Select the appropriate tailBeacon based on the known SSID of the device, as noted on the card included with the box or your maintenance records.

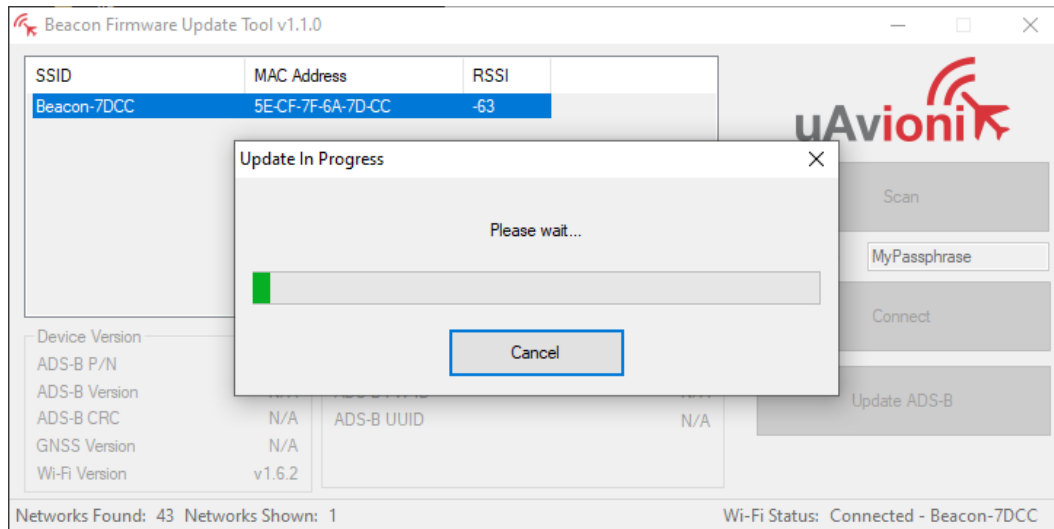
12. The update will commence. Wait for the process to complete.

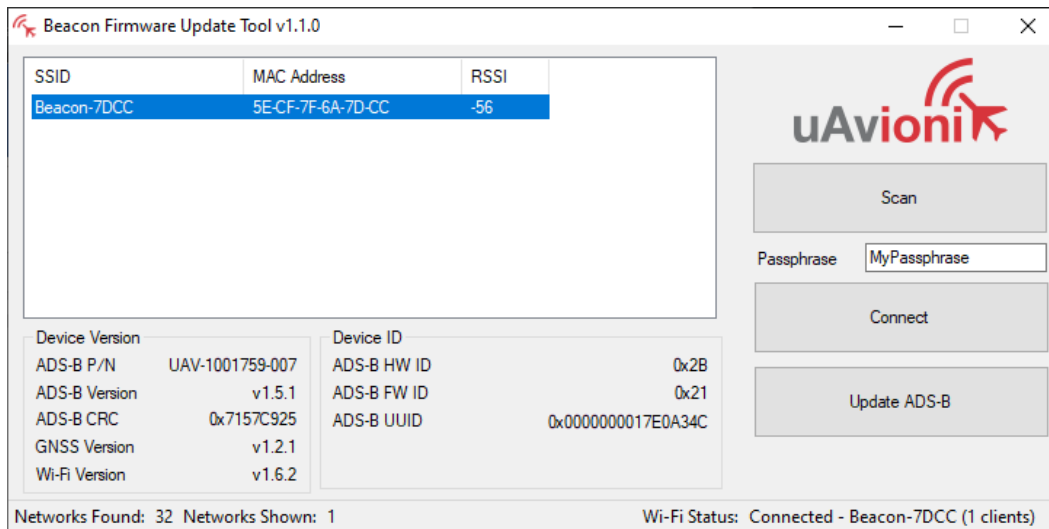
13. On completion, the progress dialog will close and the tool main screen will show the updated version and CRC information.
